No. 21/2015
ISSN 2387-4201
Observation

Andøya weather radar, damaged radome

Damaged radome due to lightning
Kjetil Stiansen, Laila F. Sidselrud

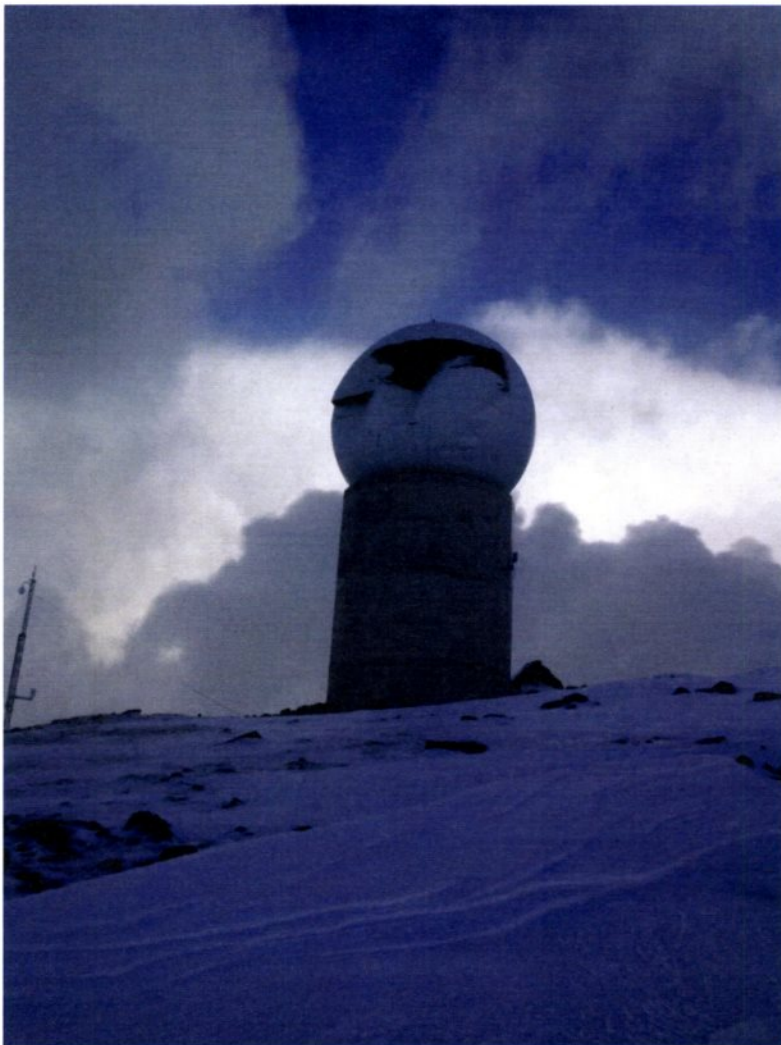
As shown on the photo, three of the radome panels were severely damaged. The structural integrity of the entire radome was weakened considerably.

There was no way that the radome would withstand the strong winds that were announced in the forecast for the next days.

Figur 2 The first picture that MET Norway received. The picture was taken by a local person who was on a ski tour

The local police were notified the same day MET Norway was aware of the situation. There was a risk that people could be hit by flying debris. Owners of the houses at the bottom of Trolltind who were in the forecasted wind direction, were made aware of the danger. Luckily no people were hit by flying radome parts and no other damages are reported.

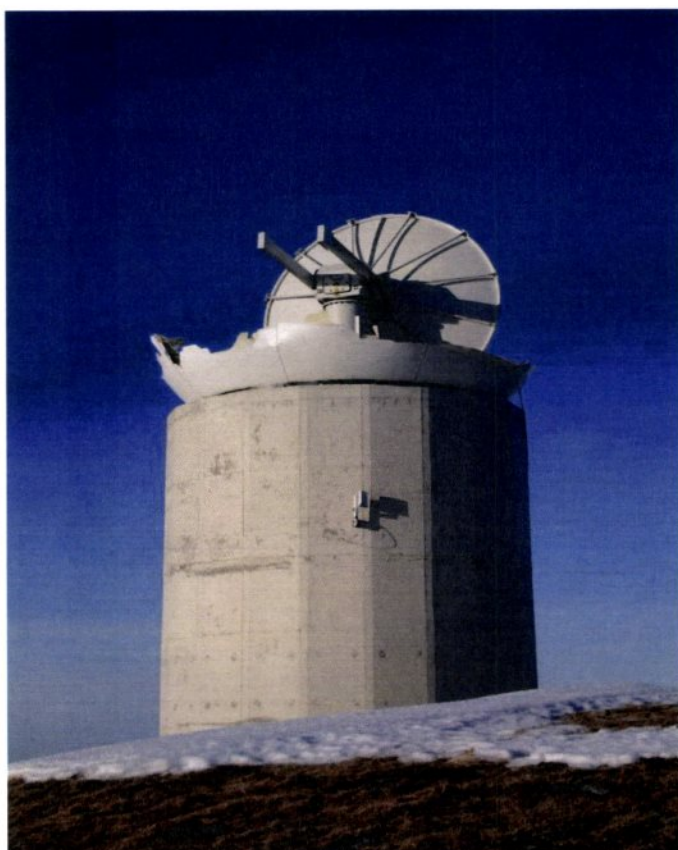
Figure 3 What was left of the radome after lightning and strong winds

The 12th of March the police was informed by locals that the majority of the radome was blown off the radar. Picture number 3 shows what was left of the radome. The picture is taken the 16th of March when MET Norway representatives were on site for inspection and securing the antenna.

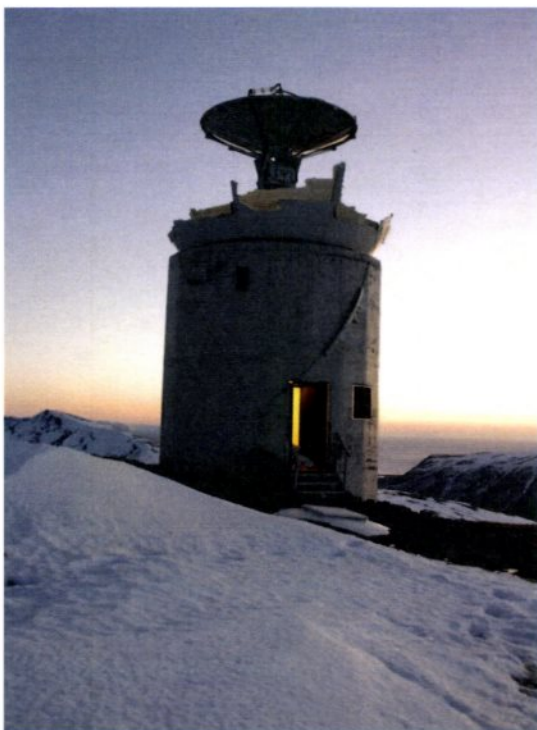
Figure 4 Antenna secured in 90 degrees angle

MET Norway representatives were able to reach the radar site on Monday the 16th of March. Main purpose for the visit was to secure the antenna in a 90 degrees angle and cover all cabinets containing radar electronics with plastic to prevent water from entering. When the radar antenna is secured in a 90 degrees angle, the antenna can Withstand wind speeds up to 120km/h.

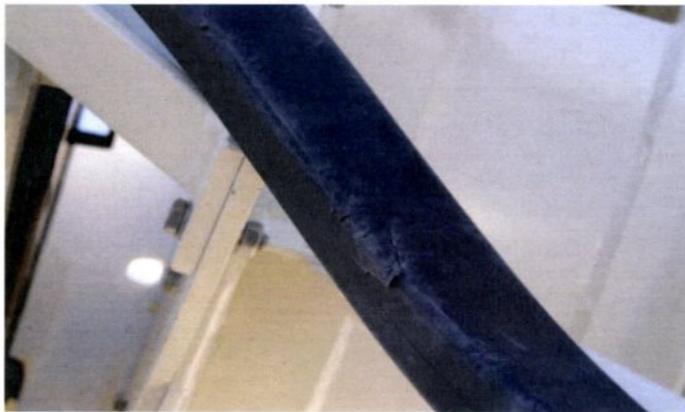
The antenna with pedestal and waveguide showed only negligible damage. The only visible “damage” to the antenna was some scratched paint and a cut/ notch in the waveguide

Figure 5 shows minor damage to the waveguide

A later inspection showed that the waveguide was broken near the antenna feed.

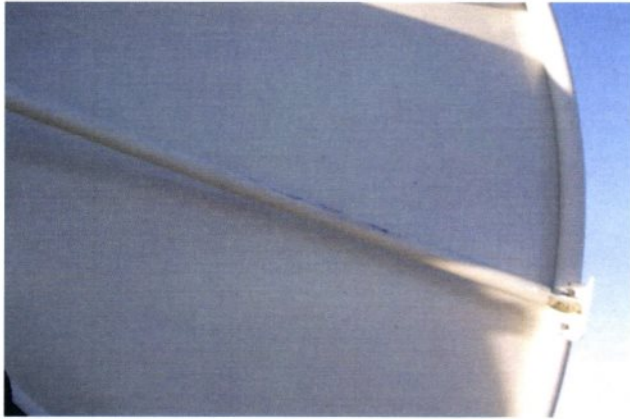
Figure 6 Scratch marks on the antenna

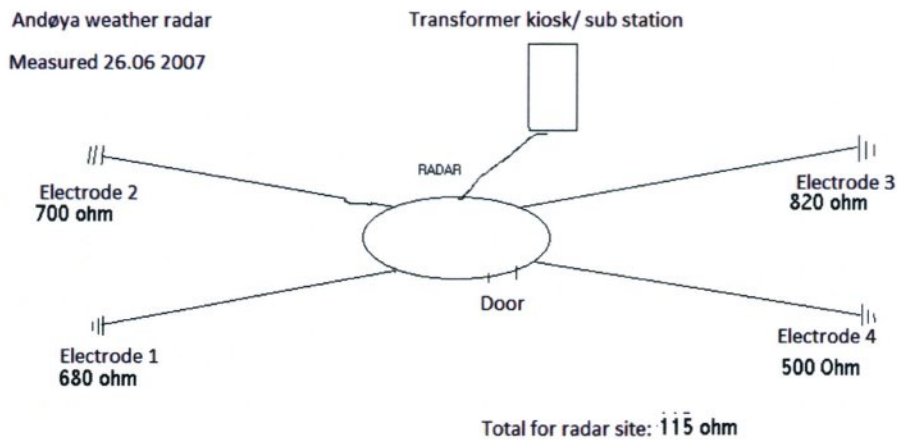
The ground around the radar consists of porous rocks. This kind of rocks has high electric conductivity and makes the values for the transition resistance from grounding rod to ground higher than desired values. The norm values for this transfer resistance are set to max 10 ohm. (We found this value in an Norwegian book on lightning protection; Lynvernhandboka published by Elforlaget).

For radar Andøya the transfer resistance are in the range 500 to 800 ohms. However, the values are within the range of what that can be expected with such soil conditions.

With equipotential bonding between all electronic cabinets and grounding rods laid out as shown in the picture, the grounding was concluded to be as good as possible in relation to the rocky soil conditions at the radar site.

Figure 7 Overview of the grounding rods and their values. Figure from Braadland Automasjon

The grounding/ equipotential bonding was improved according to their report. The report also pointed on incorrectly performed overvoltage protection.

Issues addressed in the report were corrected in August 2014 by an electrical company.

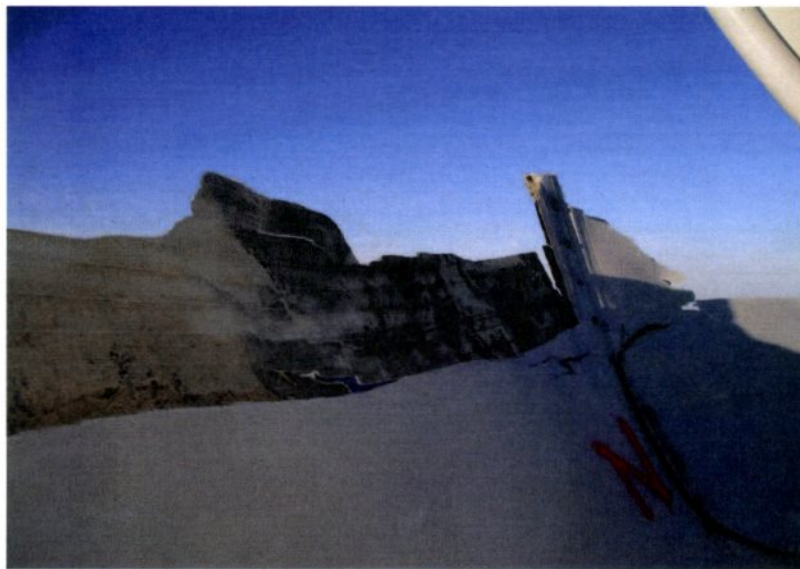
The plausible reason to the damage is that (salty sea) water was contained in the radome panel joints. In heavy weather, sea water is sprayed over the entire island. The water forms a low-ohmic impedance to the lightning transient, probably in the same range as the lightning down conductors, or even lower, because of the large surface. The transient nature of the lightning causes the currents to tend to travel on conductor surfaces, the so called skin effect.

Lightning currents are in the range of kA (kilo Amperes) and contains several hundred mega joules of energy. Such huge amounts of energy makes the water contained in the panel joints to evaporate instantaneous. The sudden evaporation makes an explosion like effect on the radome panels, and the panels are delaminated and torn apart.

Figure 8 Delaminated radome panel due to fast evaporating water induced by lightning.

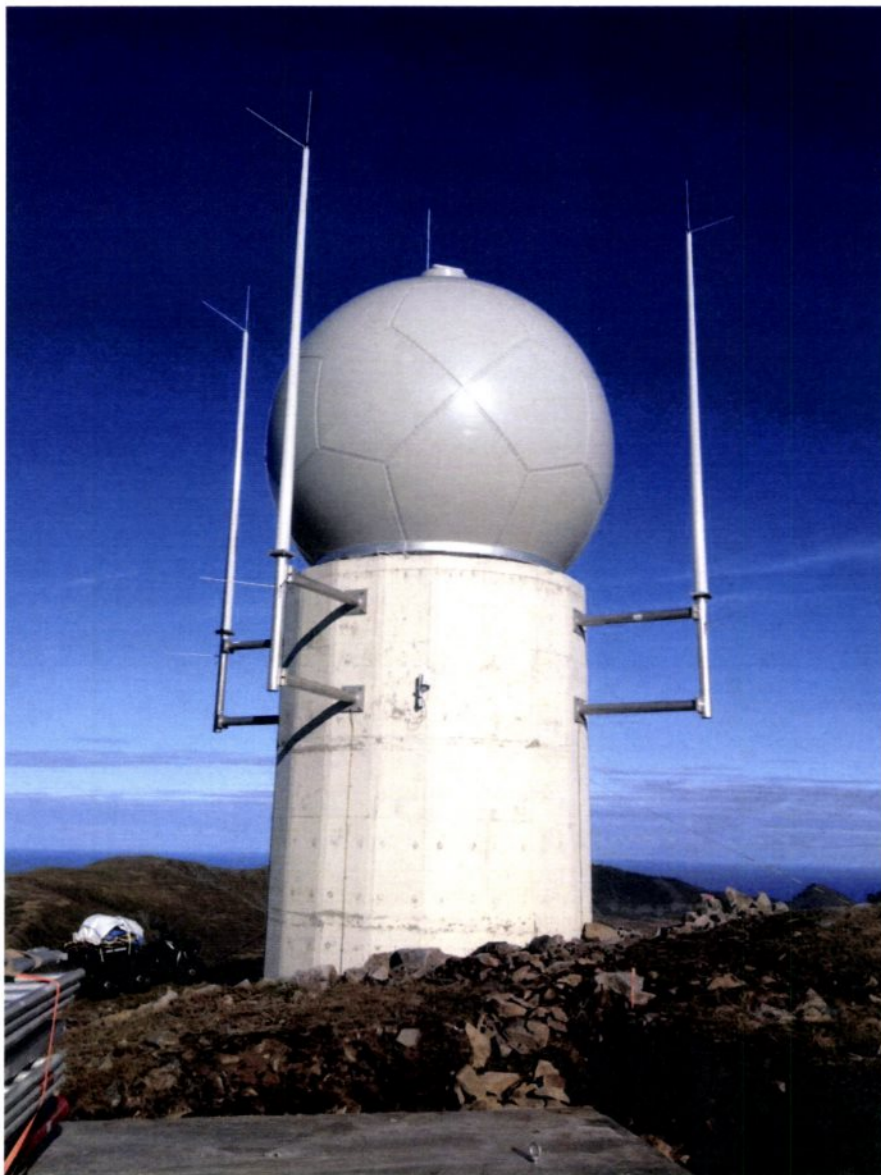
Figure 10. Picture of Andøya weather radar with the new lightning protection equipment.

The solution selected, is a solution with four lightning rods in 1,5 metres height above the surface of the radome. Each rod will be tied to its own down conductor mounted on the outside of the radar tower.

Each down conductor will be tied to the common grounding system for the whole site.

The rods ability to withstand wind and icing are about the same as the radome ability.
